Configure and Verify Ethernet 10/100/1000Mb Half/Full Duplex Auto-Negotiation

This document describes the guidelines to troubleshoot, as well as isolate and resolve, Ethernet auto-negotiation issues.

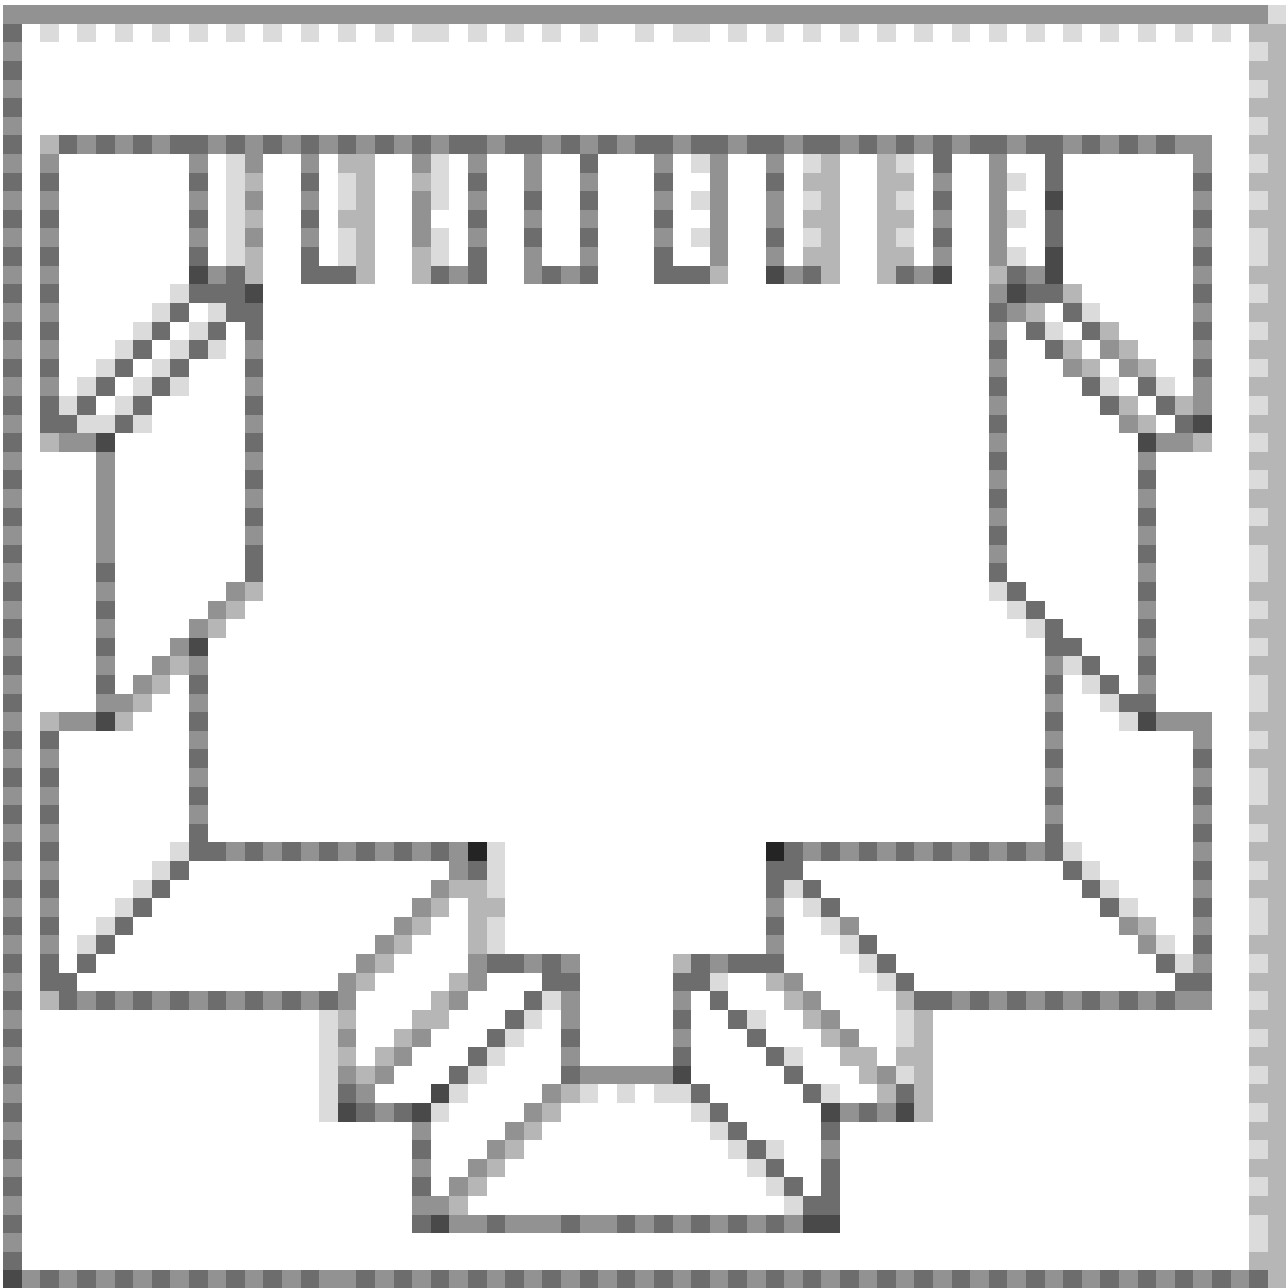
**Note:** Use a crossover cable when you connect two ports in the same layer of the OSI model, such as router to router (Layer 3) or switch to switch (Layer 2). Use a straight-through cable if the two ports are in different layers, such as router to switch (Layer 3 to 2) or PC to switch (Layer 3 to 2). For this rule, treat a PC as a Layer 3 device.

1 2 3 4 5 6 7 8

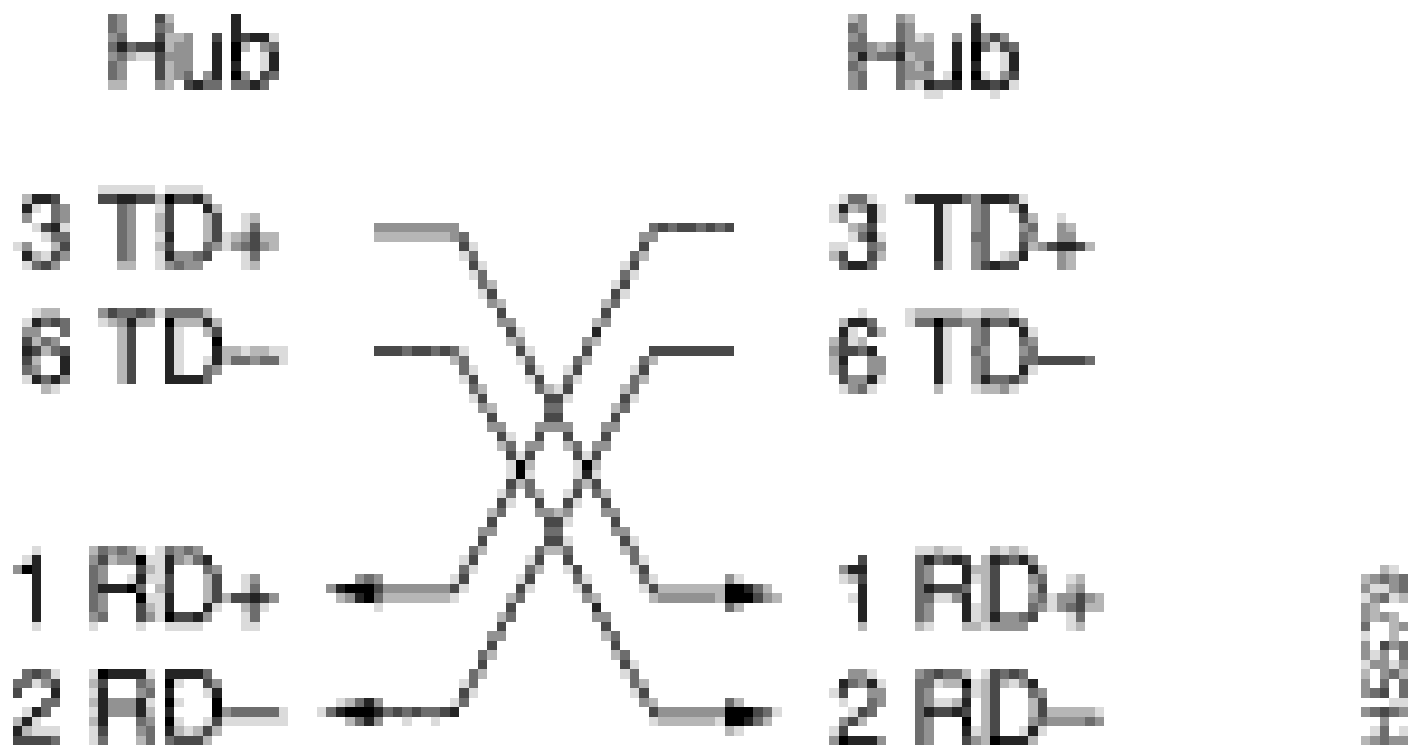
Ethernet Crossover Cables Available at Stores

CAT5/CAT6 10/100/1000BaseT UTP crossover patch cables are available from most computer stores.

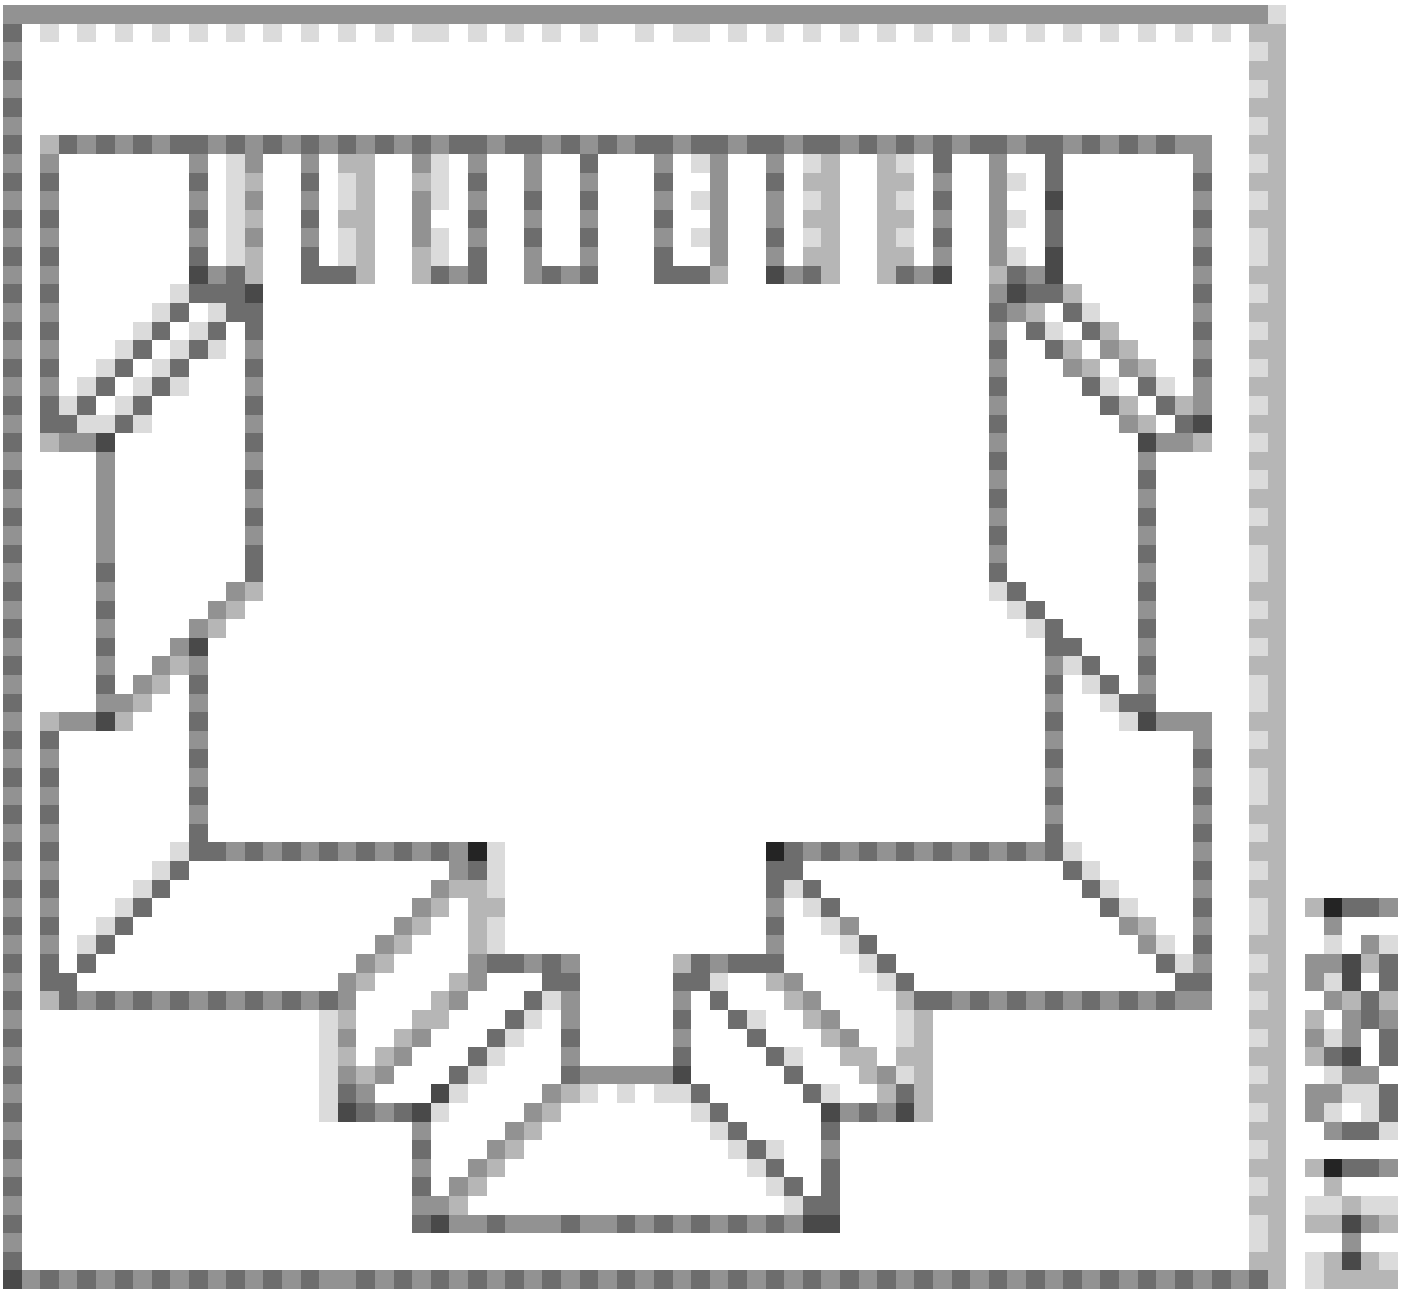
Four Twisted-Pair Crossover Cable Schematics 1

Four Twisted-Pair Crossover Cable Schematics for 10/100/1000 and 1000BASE-T GBIC Module Ports

1 2 3 4 5 6 7 8

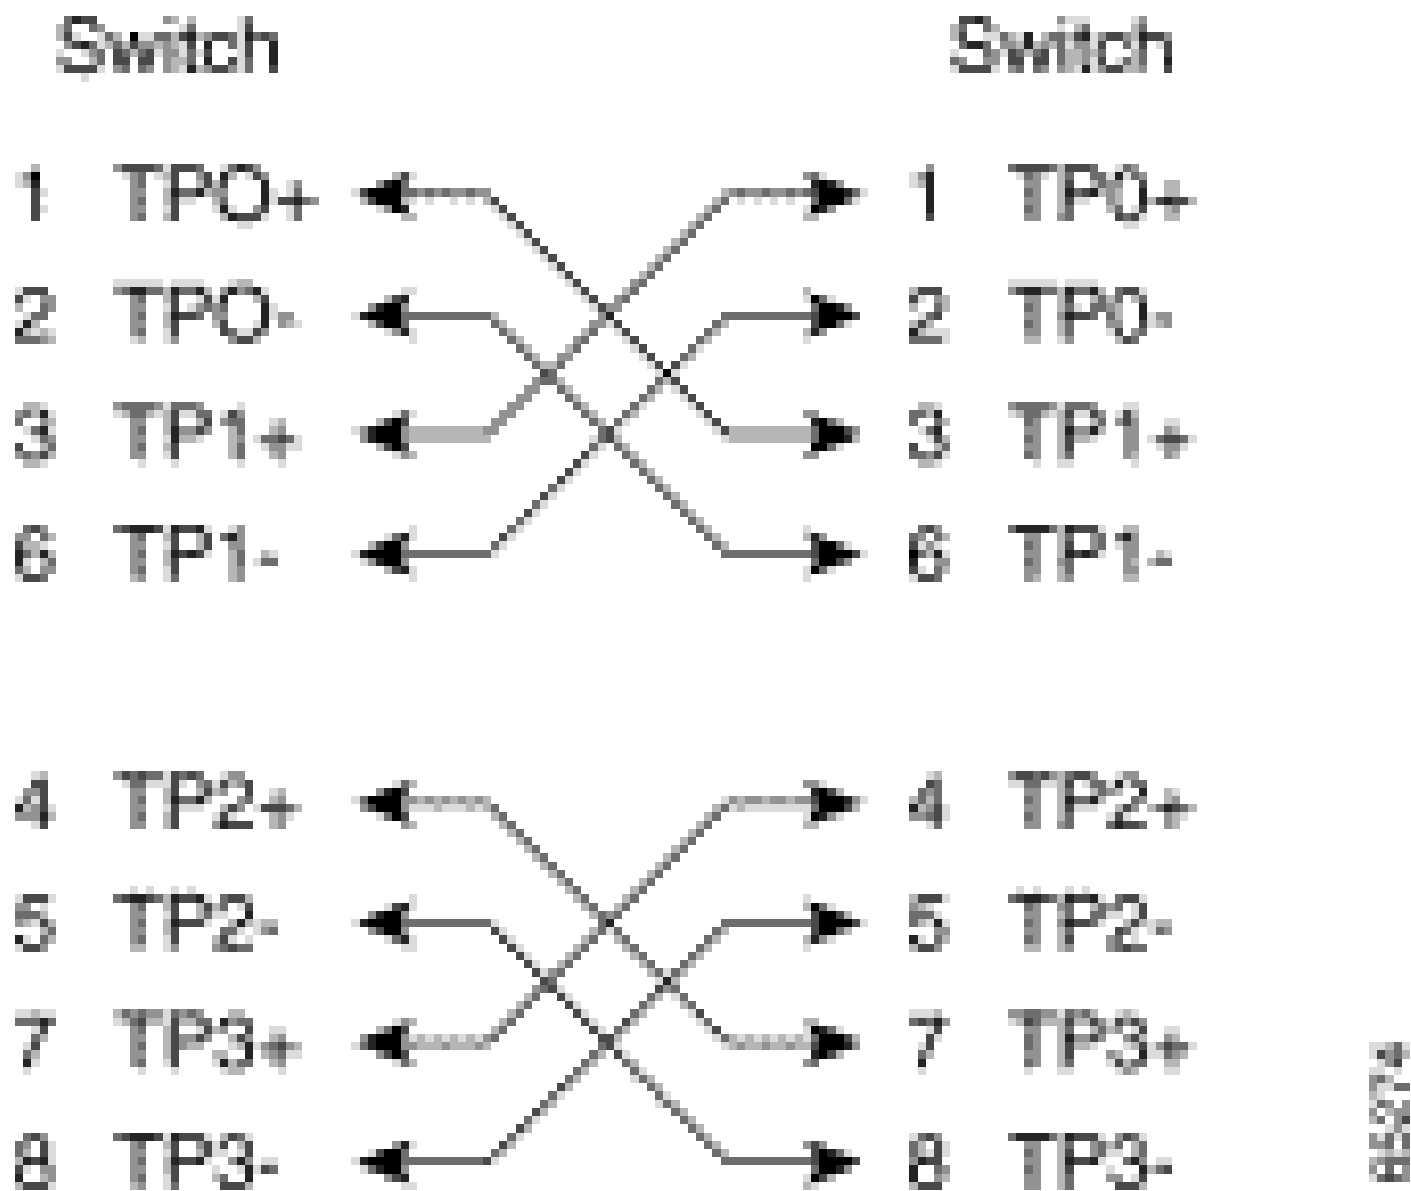
Four Twisted-Pair Crossover Cable Schematics 2

CAT 5, 5e or 6 UTP crossover patch cables are available from most computer stores.
